**RE: QUARTERLY PROGRESS REPORT FOR THE AVTEX FIBERS SUPERFUND SITE FOR THE
PERIOD JULY 1 THROUGH SEPTEMBER 30, 2021 (THIRD QUARTER)**

SITEWIDE QUARTERLY INSPECTION REPORTS

Quarterly Inspection Report Photographic Log
Avtex Superfund Site
Front Royal, Virginia

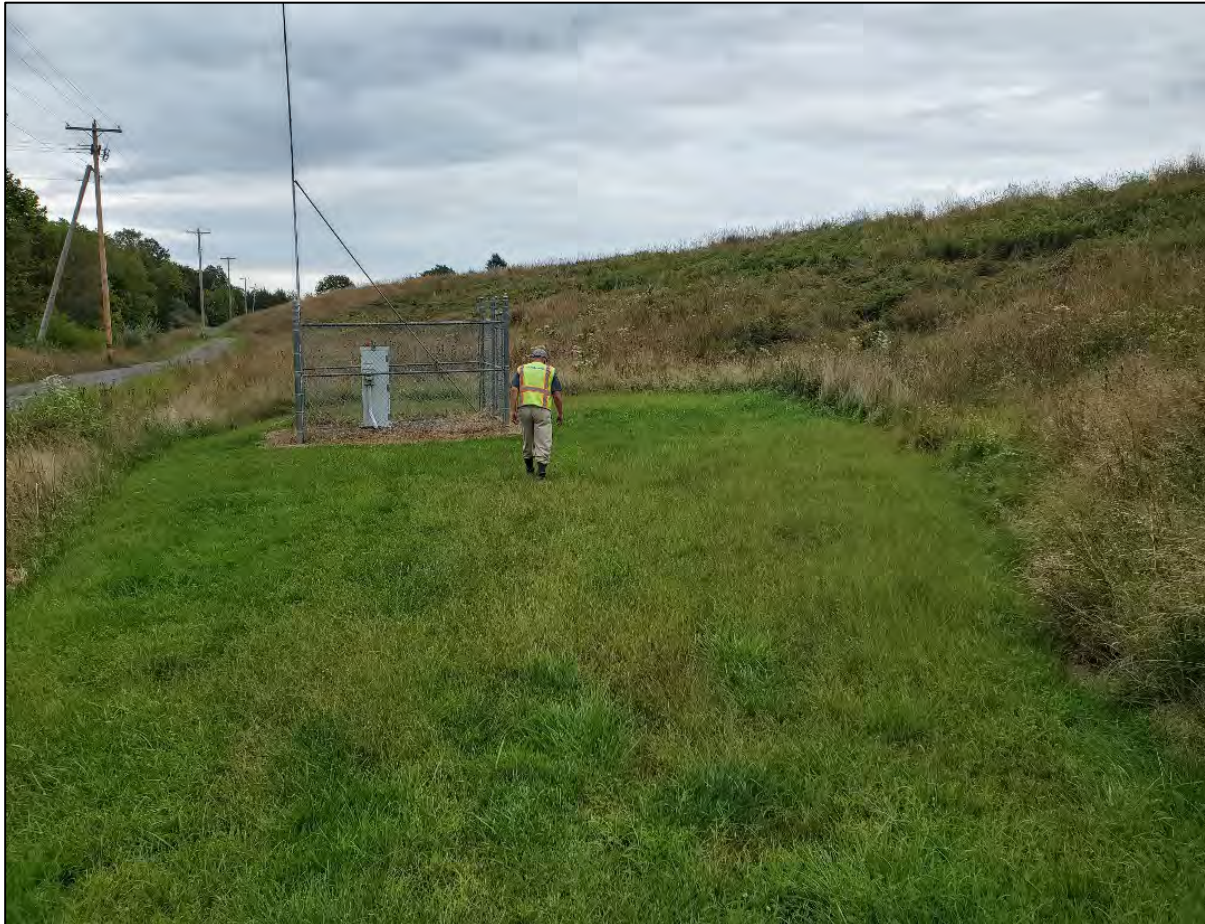
Photo Number: 1

Photo Description: Area of former standing water adjacent to LS-2 (dry).

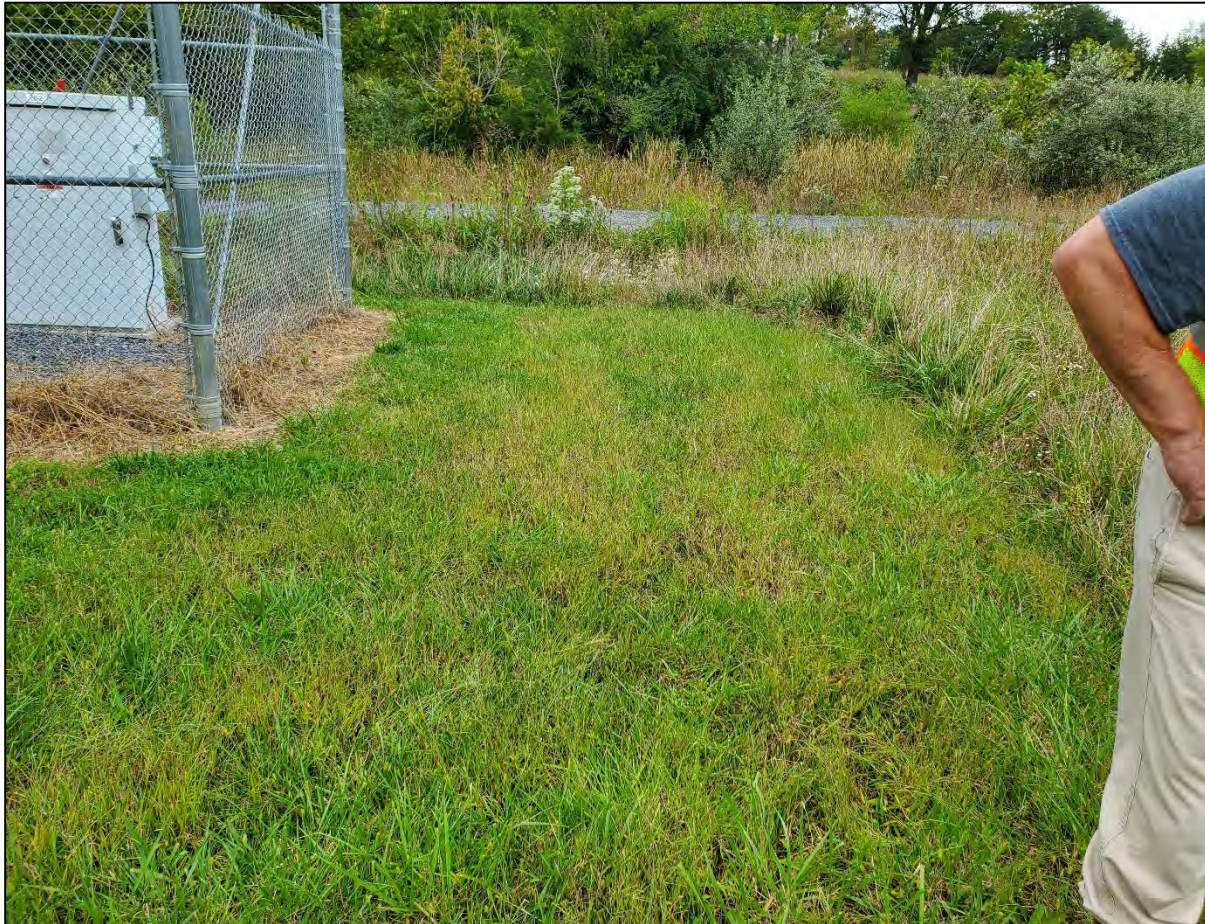
Photo Number: 2

Photo Description: Area of former standing water adjacent to LS-2 (dry).

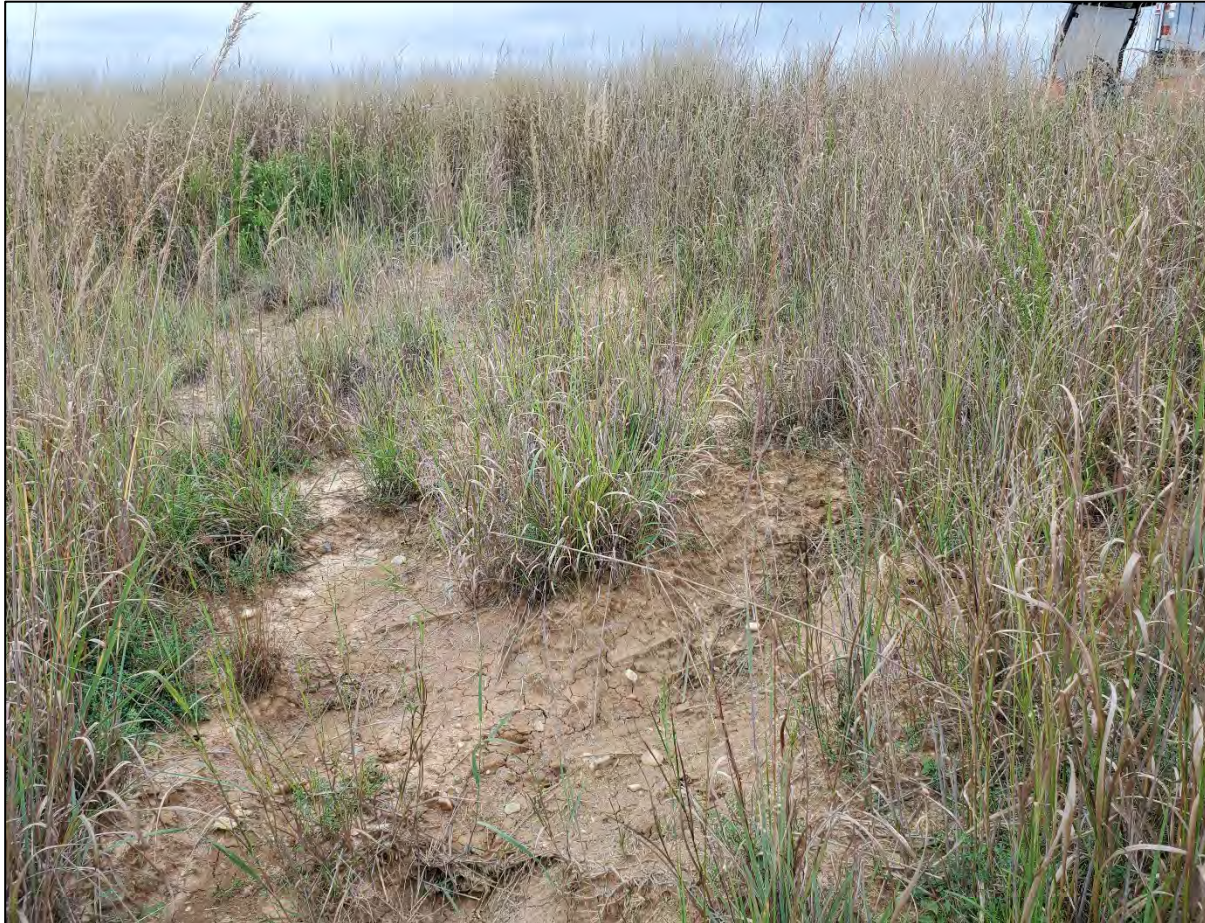
Photo Number: 3

Photo Description: Bare soil (~10' x30`) with rills southeast of VB-2&3 (Sediment basin between NFL and VB-2&3). Appears stable.

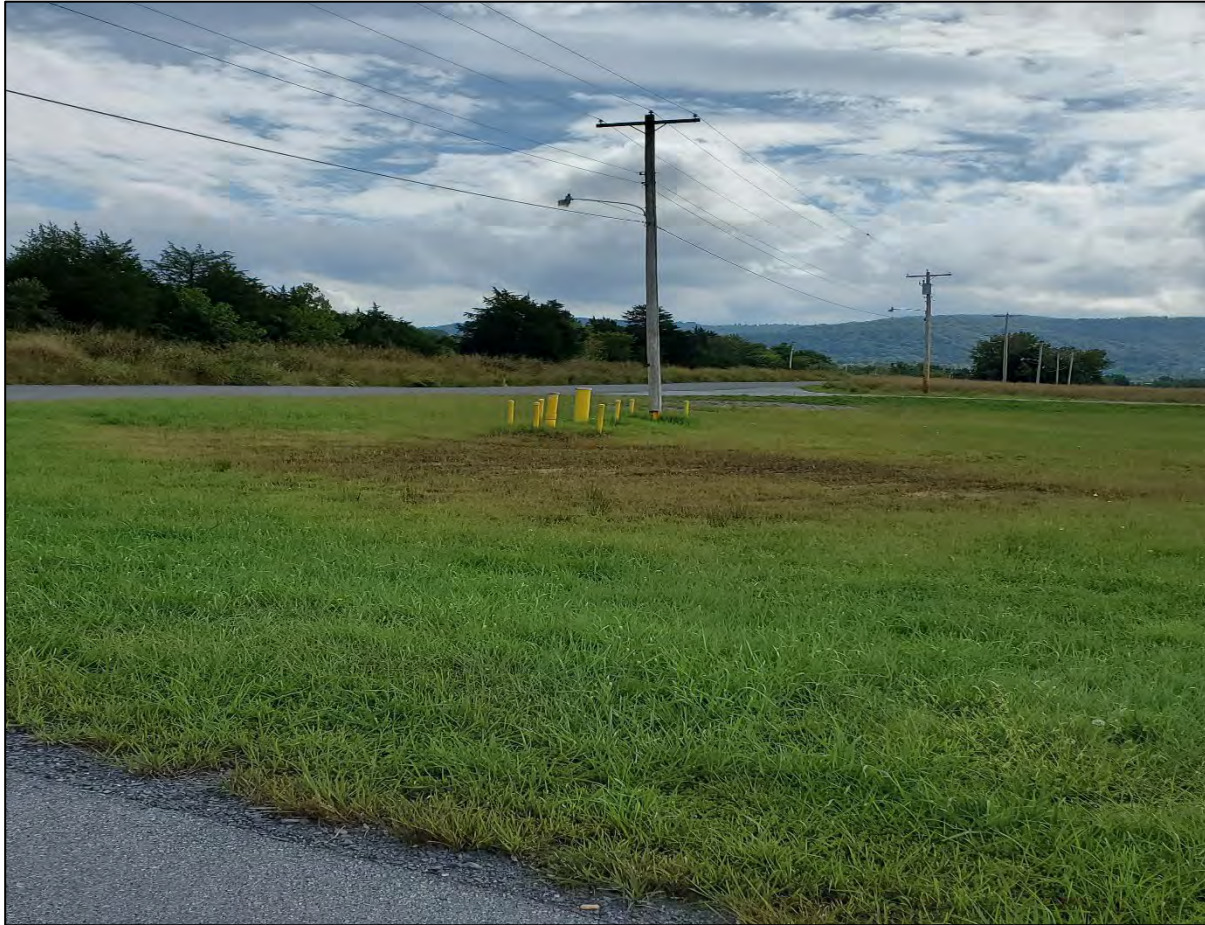
Photo Number: 4

Photo Description: Area around wells 103/203/303 – dry

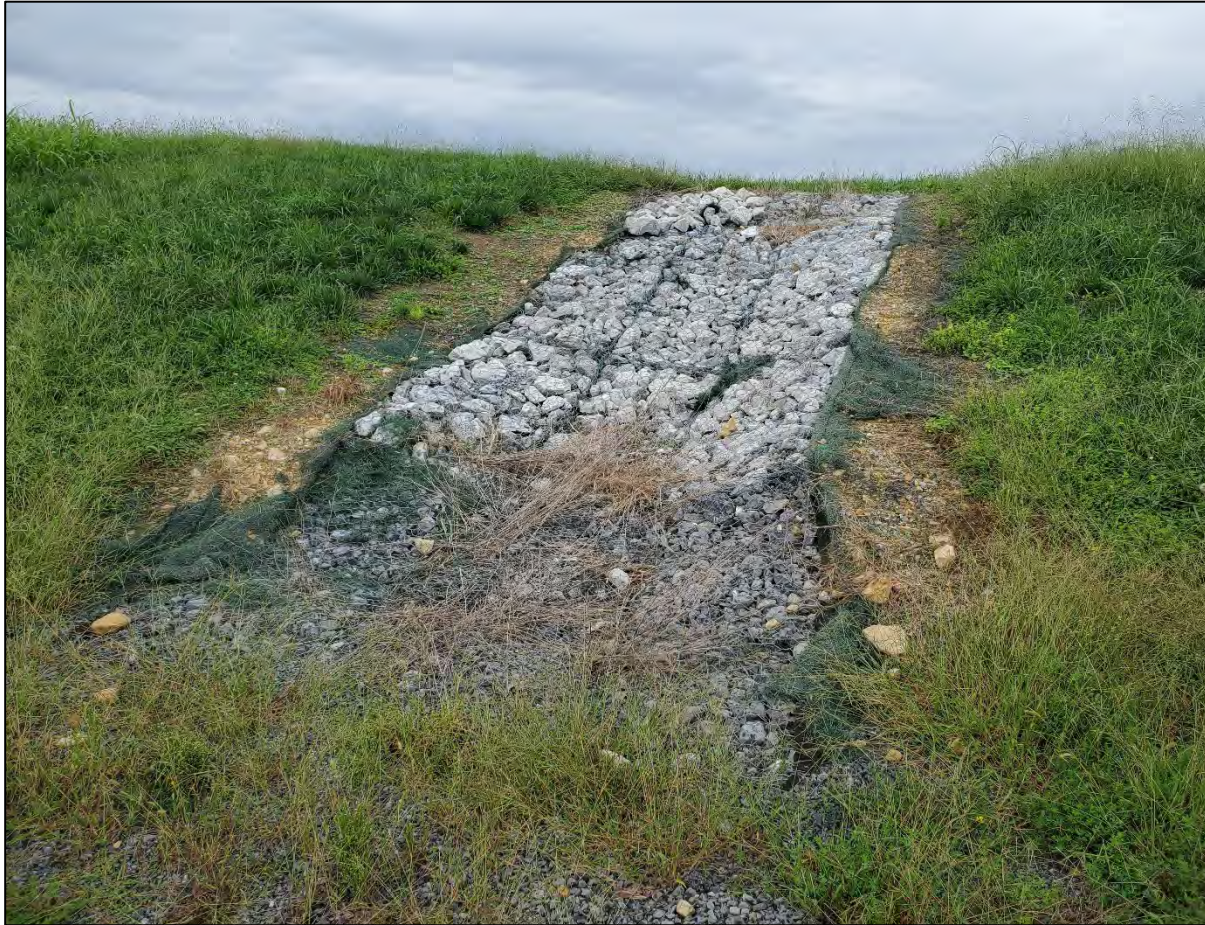
Photo Number: 5

Photo Description: Bare patches and exposed matting at down chute in south side of VB-10 - stable

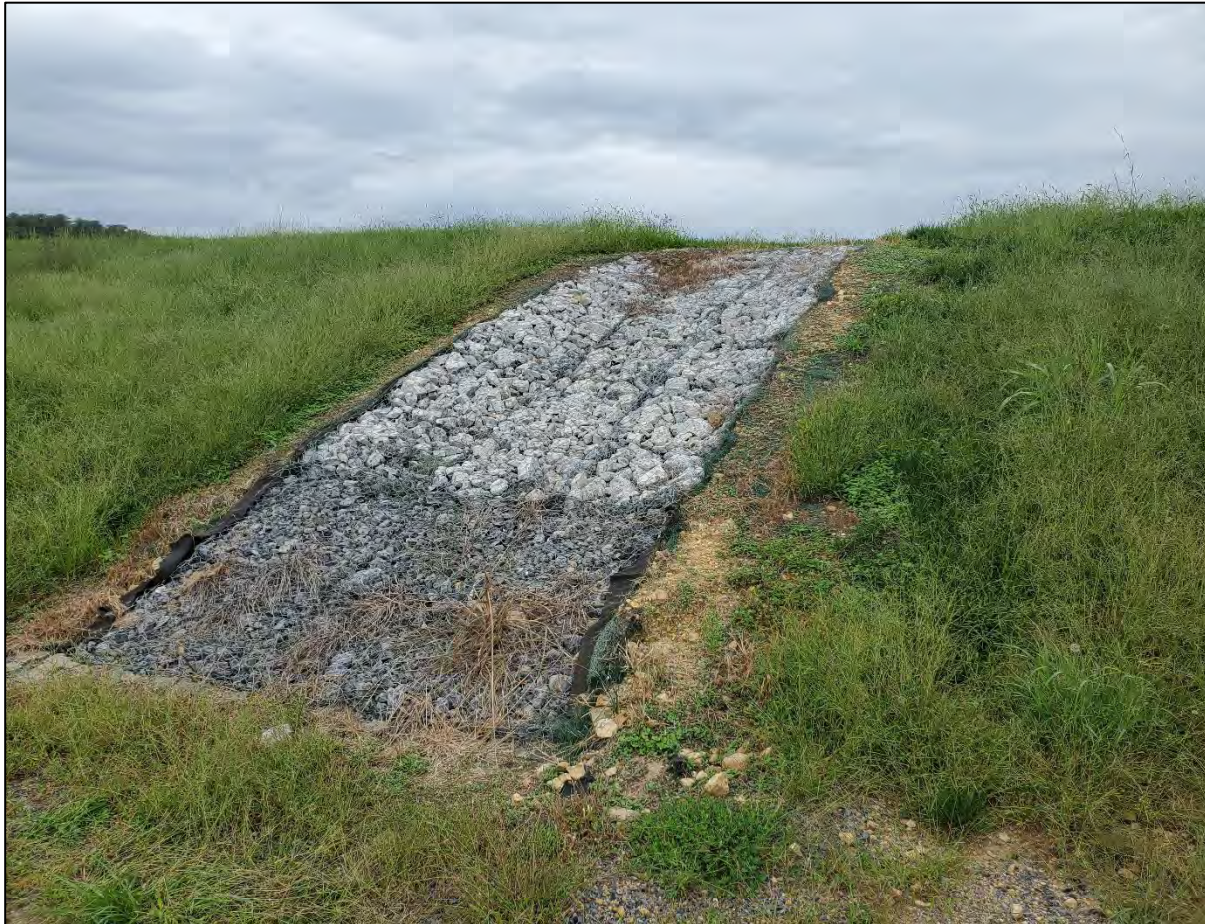
Photo Number: 6

Photo Description: Bare patches and exposed matting at down chute in south side of VB-10 - stable

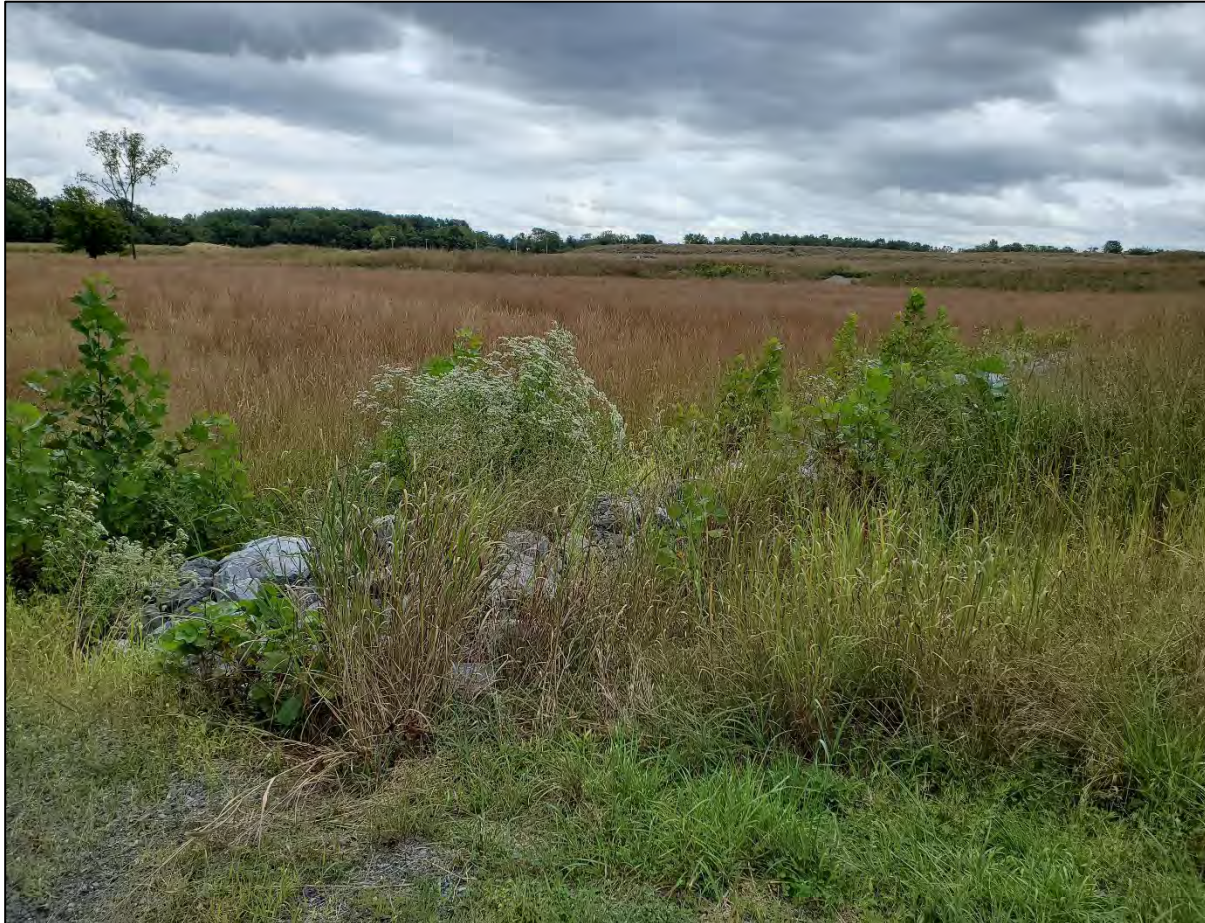
Photo Number: 7

Photo Description: Small trees in rip rap (less than one-inch diameter or five feet tall).

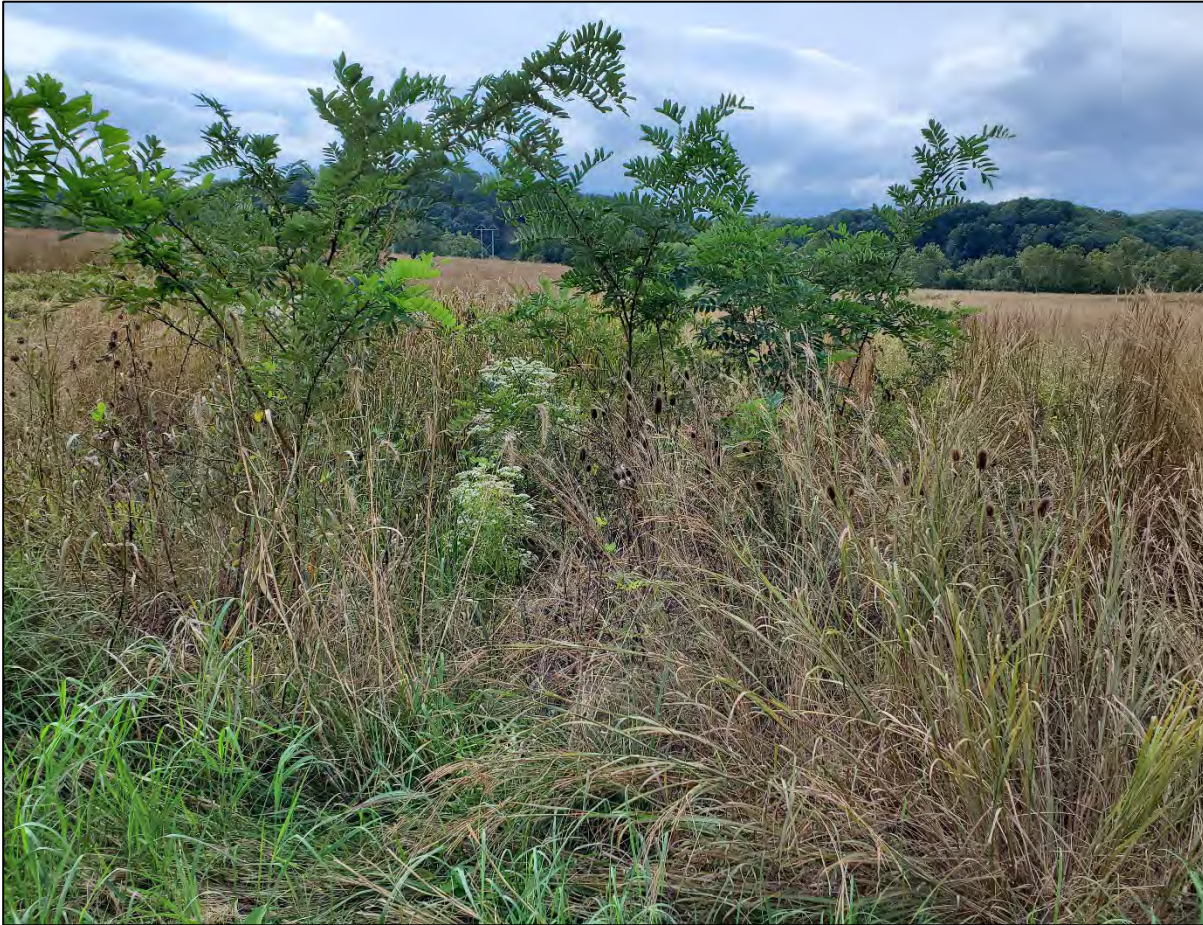
Photo Number: 8

Photo Description: Four or five small trees in ditch (less than two-inches diameter or five feet tall).

Four to Five small tree in
drainage ditch; currently less
than 2" dia / 5' tall (See Photo 8)

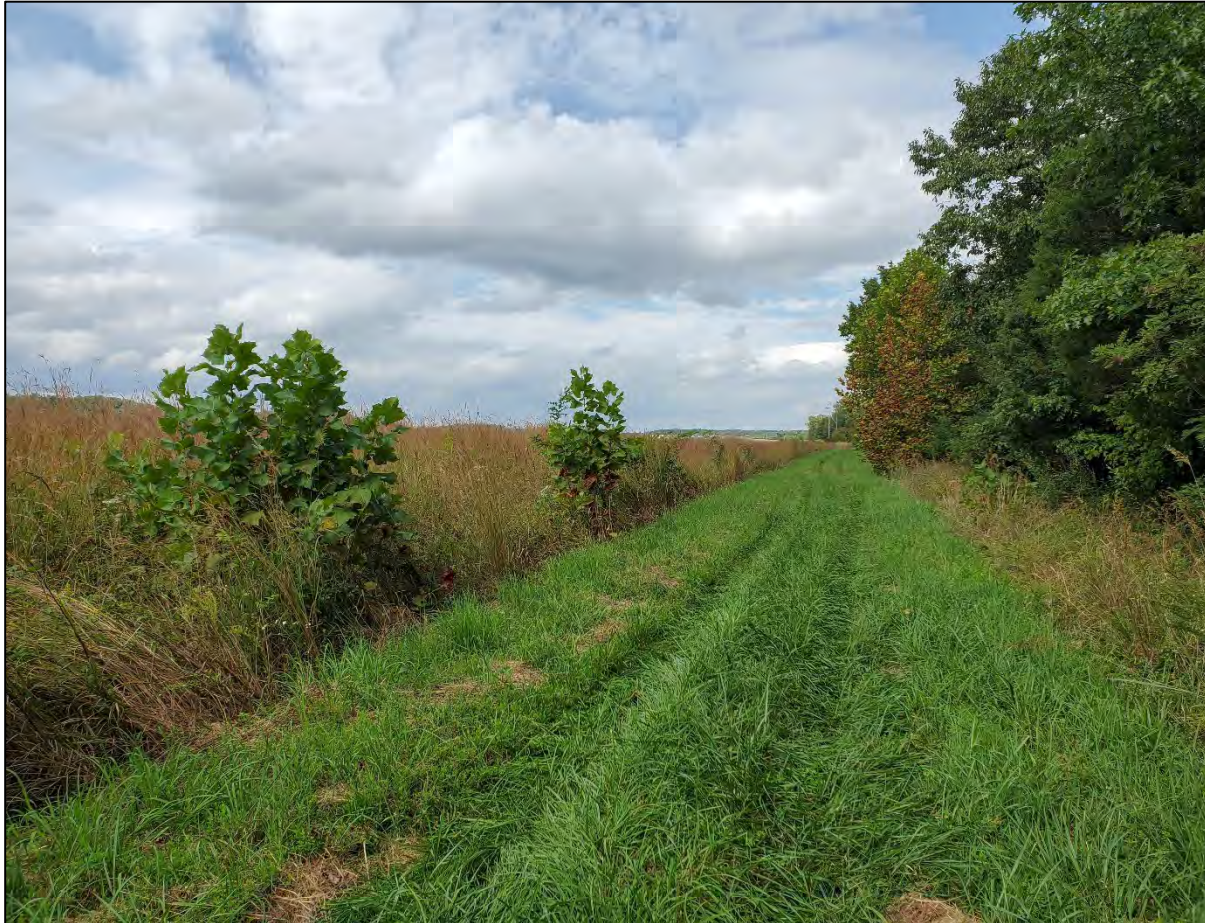
Photo Number: 9

Photo Description: Several small trees in ditch (approaching five feet tall).

Several small tree in drainage
ditch; approaching 5' tall (See
Photo 8)
